# Toyota Parking Aid 400

## TPA 400

Troubleshooting Manual - Typical performance graphs

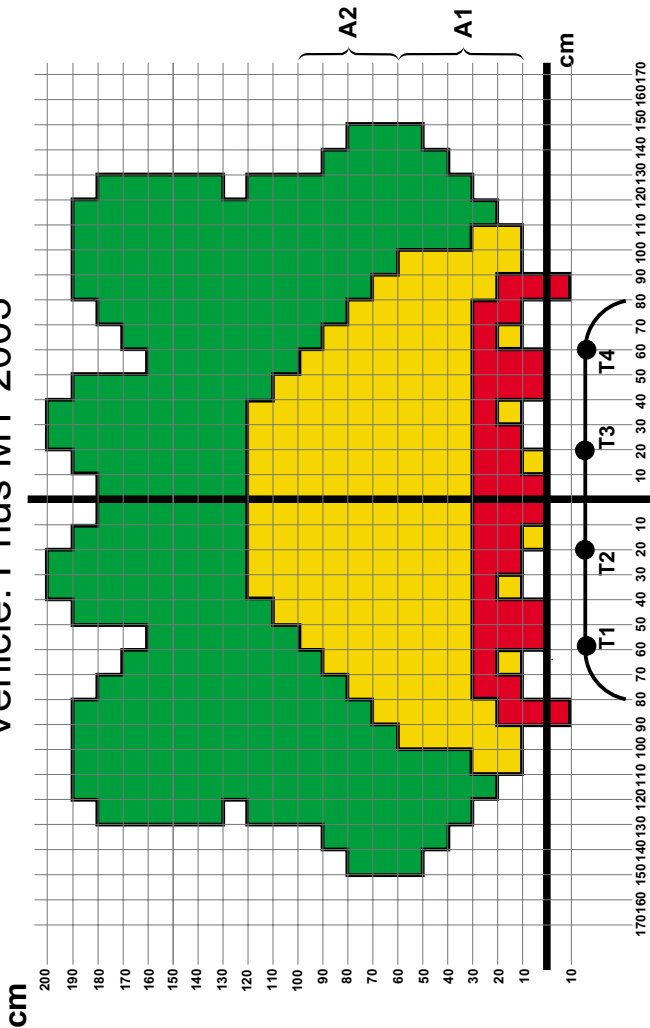
# Vehicle: Prius MY 2003

- CONTINUOUS SIGNALLING ZONE  
(Continuous acoustic signal)
- STATIC ZONE  
(Intermittent acoustic signal if the vehicle is standing)
- DYNAMIC ZONE  
(Intermittent acoustic signal if the vehicle is moving)

*The final performance of the TPA 400 system is depending on vehicle conditions (height from ground , load status), ambient conditions (kind of ground surface and walls around, clean sensors external surface, ultrasonic sources, ambient temperature) and installation tolerances, especially for the dynamic covering zone.*
